ATTENTION !!!

RECOMMENDED INSTALLATION PATTERNS

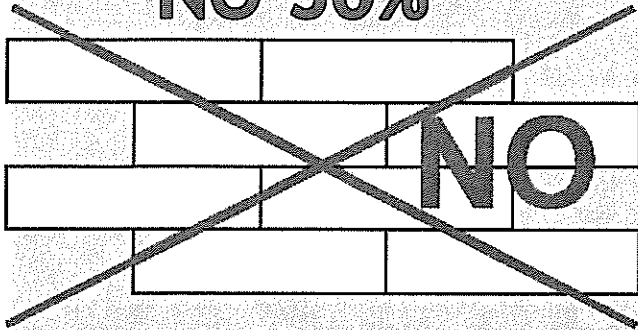
NO 50%

1/2 BROKEN JOINT NOT RECOMMENDED

**THE OVERLAP SHOULD NOT EXCEED 33%
WHEN INSTALLING RECTANGULAR SIZES
IN A STAGGERED BRICK-JOINT PATTERN.**

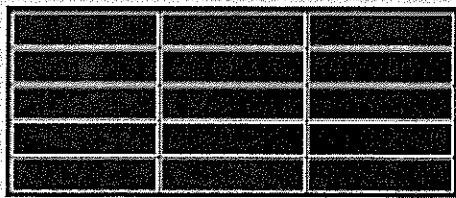
STRAIGHT LAY

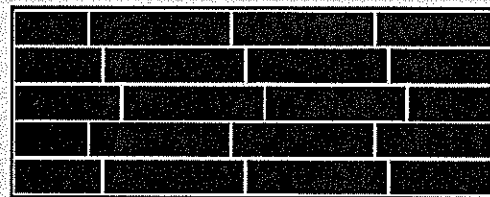
ALTERNATING FORMAT

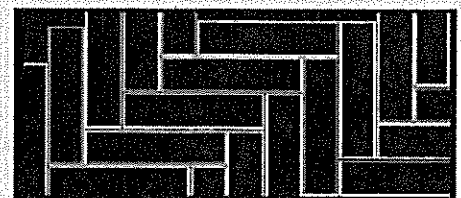
HERRINGBONE
